NASA TM X-1773

FLIGHT-TEST RESULTS FROM SUPERSONIC DEPLOYMENT OF AN 18-FOOT-DIAMETER (5.49-METER) TOWED BALLUTE DECELERATOR

by Robert J. Mayhue and Clinton V. Eckstrom

Langley Research Center

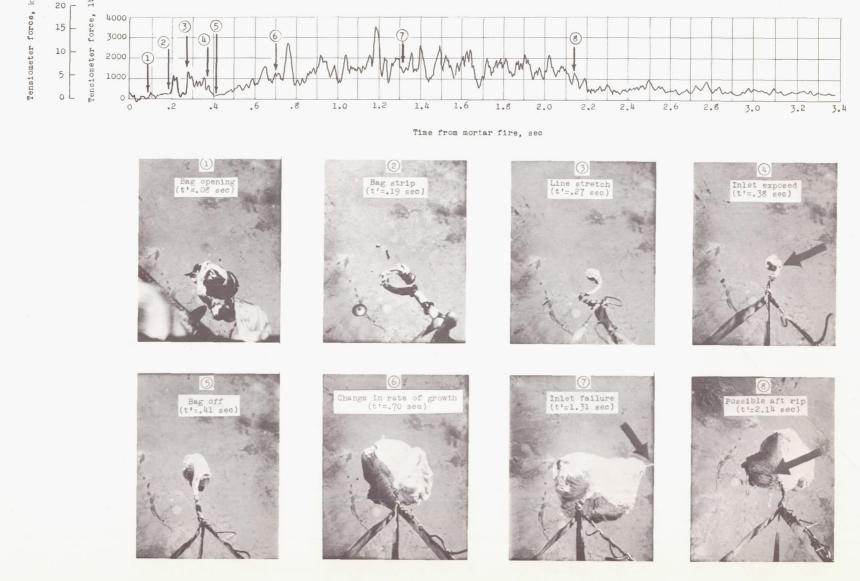
The photographs, taken with the rearward-facing camera, and corresponding tensiometer forces (fig. 7) indicated normal deployment, extraction, and filling of the test ballute up to about 1 second after mortar firing. Then ballute growth appeared to stop and an average plateau drag force of 1500 pounds (6.7 kN) was maintained during the time interval between about 1 and 2 seconds. The maximum force anticipated at full inflation was of the order of 3800 pounds (17 kN). A sudden drop in the drag force then occurred, followed by a slow decay to approximately 300 pounds (1.3 kN) for the duration of the flight.

Figure 7.- Photographs of deployment and inflation with tensiometer forces.

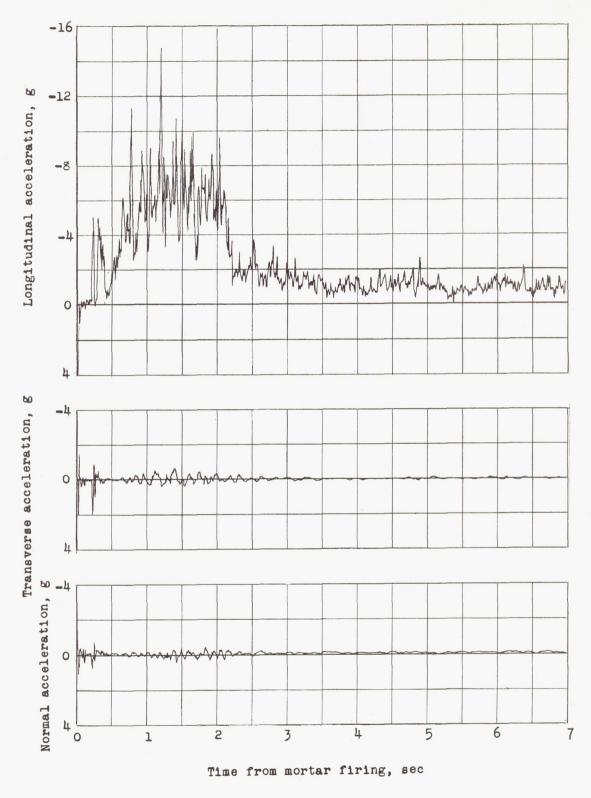
The payload longitudinal accelerations shown in figure 8, as well as the comparison of time histories of tensiometer forces in figure 9 with a typical ballute inflation envelope, verified normal inflation of the ballute up to about 0.7 second after mortar firing. About this time, the rate of change of ballute growth decreased until no further filling could be observed beyond 1 second after mortar firing. (See fig. 7, photograph ⑥.) After ballute growth stopped, a structural failure occurred at about 1.3 seconds, as shown by photograph ⑦ of figure 7. This failure consisted of an inlet reinforcement spring parting from the fabric at the leading edge and flailing at the end of the inlet erection straps. Up to this time, no other structural damage could be observed from the film as illustrated by the selected photographs of figure 10.

1. After initial filling, a buildup of whipping action of large areas of envelope fabric (observed in the film data, and reflected in the longitudinal measurements of figs. 8 and 9) caused the inlets to be either buried within the fabric or turned to positions of ineffective operation (fig. 10). Prolonged whipping action eventually led to failure of the fabric at the inlet leading edge and little additional filling was achieved. Plateau drag forces that were developed from initial inflation pressures were then maintained until an aft-end rip occurred, which spilled most of the volume of air present within the ballute envelope.

Figure 8.- Time histories of payload accelerations.

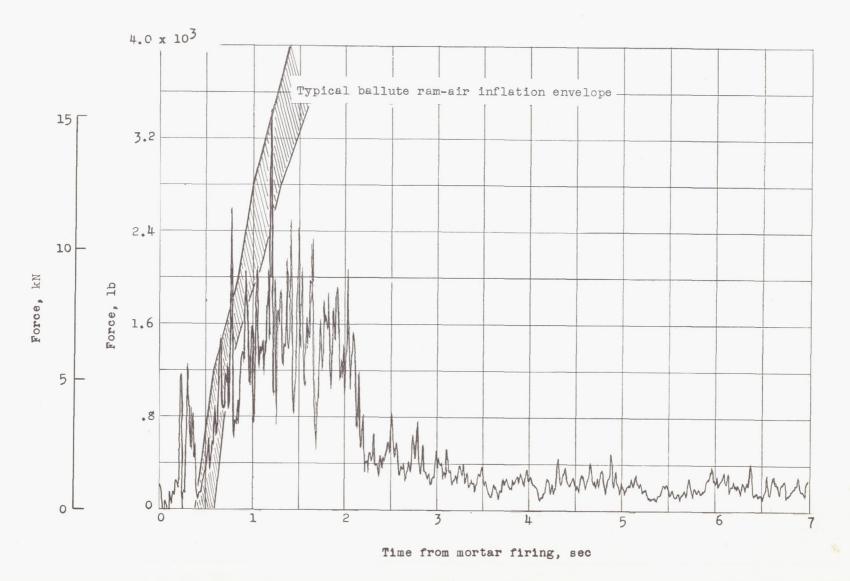
Figure 9.- Time history of tensiometer force measurements.

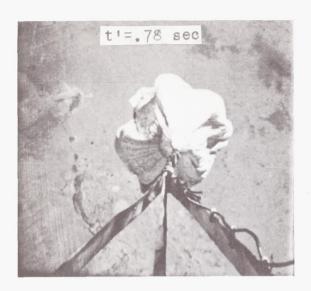
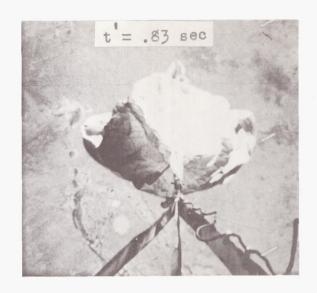
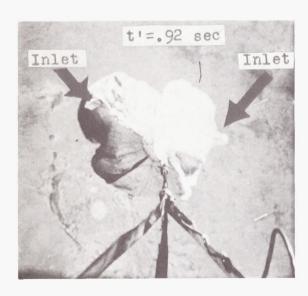
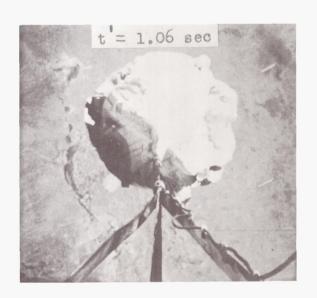
(a) Maximum force, 2600 lb (11.56 kN).

(b) Minimum force, 600 lb (2.67 kN).

(c) Maximum force, 2100 lb (9.34 kN).

Figure 10.- Photographs of ballute inflation prior to inlet failure.

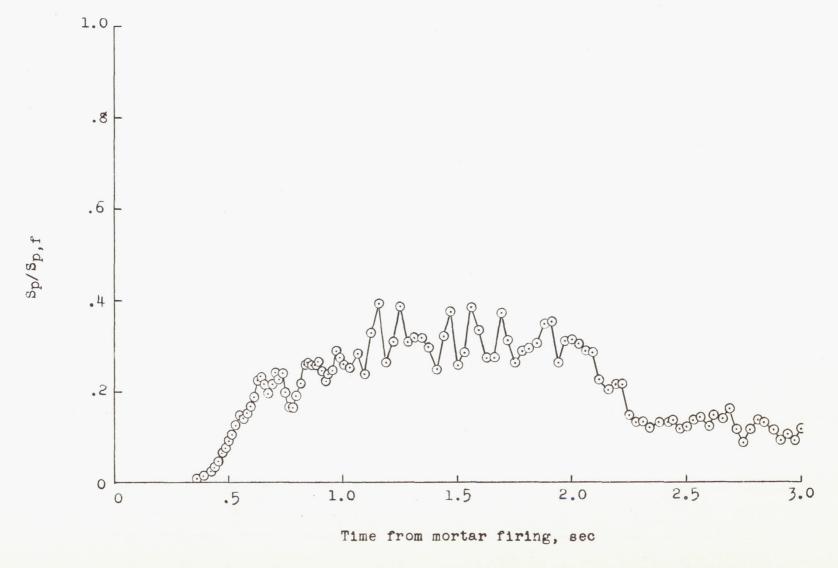
Figure 11 shows that 30 percent of the expected total frontal area was achieved from initial filling, and was maintained over a 1-second time interval. During this time interval, inlet failures were observed but there was no evidence of failure of the basic ballute envelope fabric. The first definite photographic evidence of envelope fabric failure was in the form of a large aft-end rip which was noted approximately 34 seconds after mortar firing, as shown in figure 12.

Figure 11.- Time history of projected-area ratio.

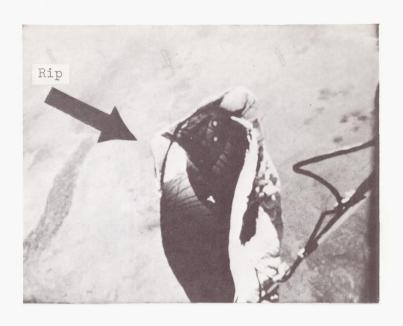
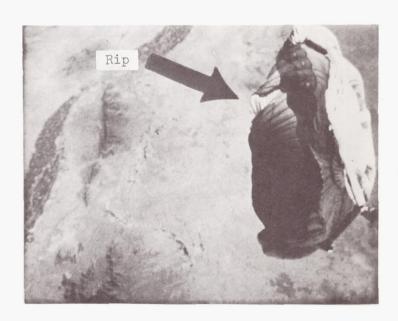
2. Development of an aft-end rip occurred during the initial inflation process as the result of fabric whipping action or other unknown causes. This fabric failure offset further inflation through the operating inlets by loss of pressure through the back so that plateau drag forces were maintained over a 1-second interval. Prolonged whipping action of the fabric led to enlargement of the aft-end rip, which spilled the existing volume of air within the ballute envelope.

Figure 12.- Photographs of aft-end rips (t'  $\approx$  34 sec).

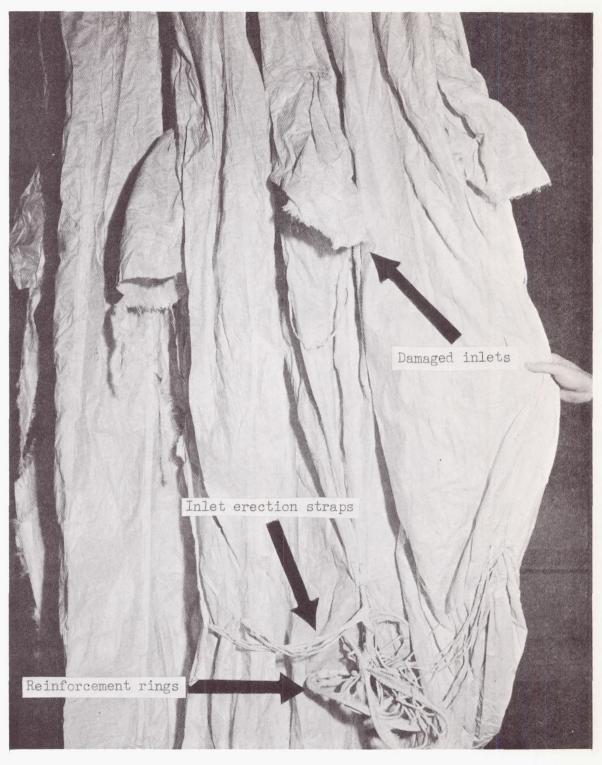
An inspection of the recovered test ballute revealed three areas of major damage. The first area was the failure of six of the inlet leading-edge reinforcement springs. During flight, these springs entangled in two groups of three rings each as shown in figure 13. The second area of major damage was two parallel tears from the center of the back portion of the ballute down to the burble fence, as shown in figure 14. Four additional tears were located in the forward conical section, two of which are shown in figure 15. The tears in the forward section were not observed in the flight film and therefore probably occurred during the later descent portion of the flight.

Figure 13.- Failure and entanglement of inlet reinforcement rings.

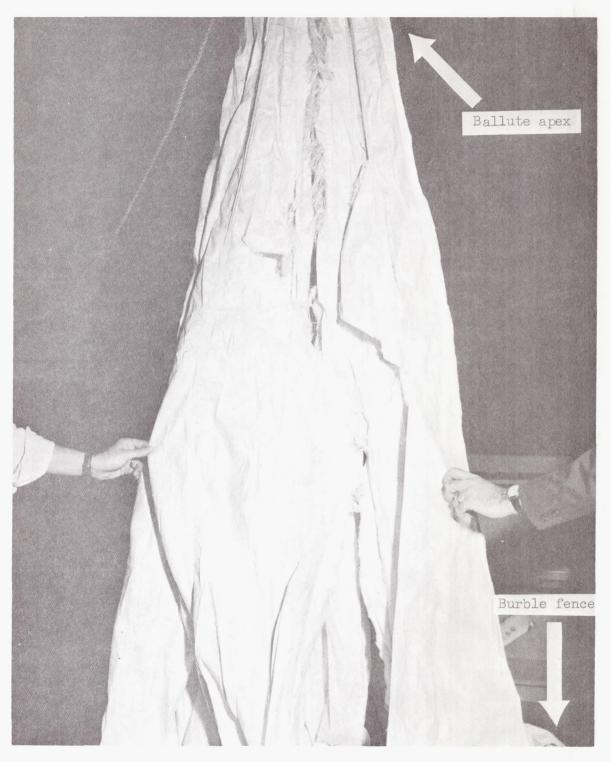
Figure 14.- Tears in back portion of ballute down from apex to burble fence.

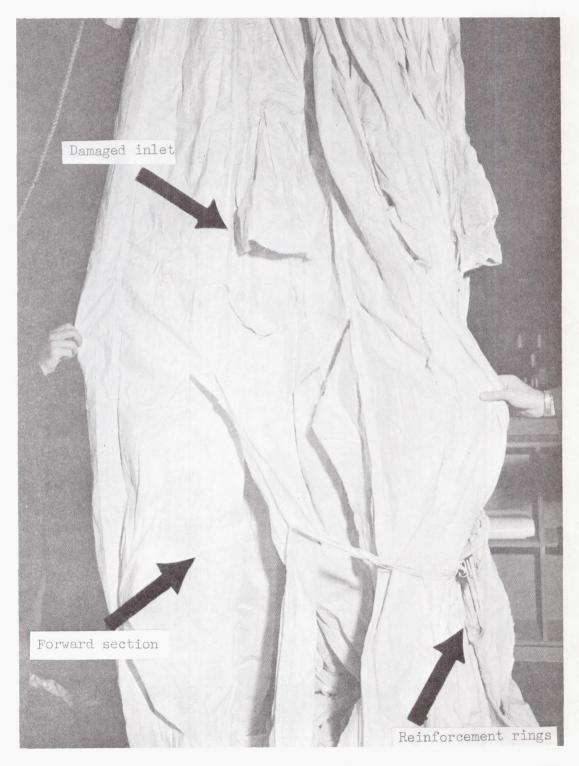
Figure 15.- Tears in forward section.
